The December 7, 1988 Armenia, USSR Earthquake

An EQE Summary Report

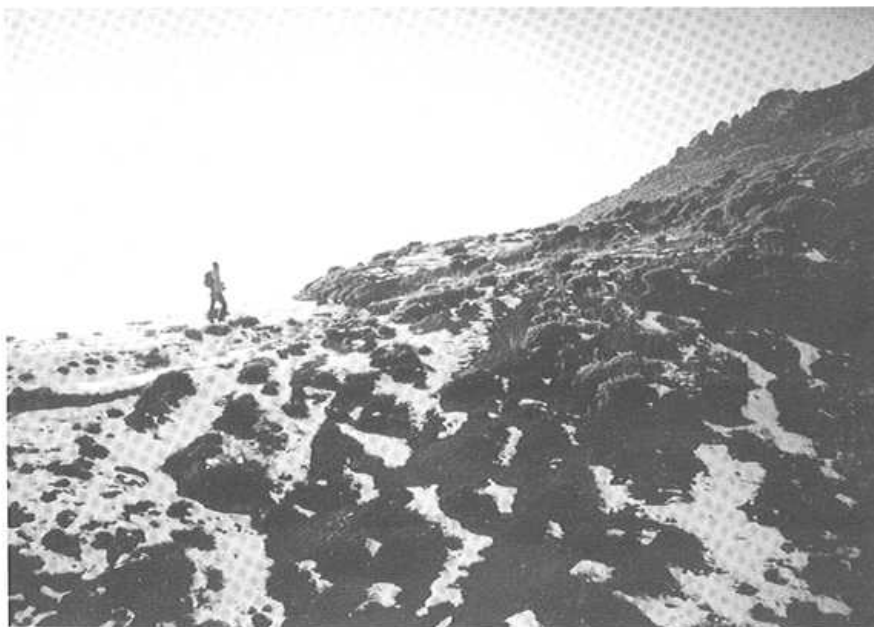
Surface faulting approximately two miles southwest of Spitak. The figure is standing on the south plane of the fault, facing the north plane, which lifted upward. The raised ground directly in front of the figure shows the vertical component of the slippage, which was at its maximum near this point. The ground profile in the center of the photo had been smooth prior to the earthquake. (Photo courtesy of R. Sharpe.)

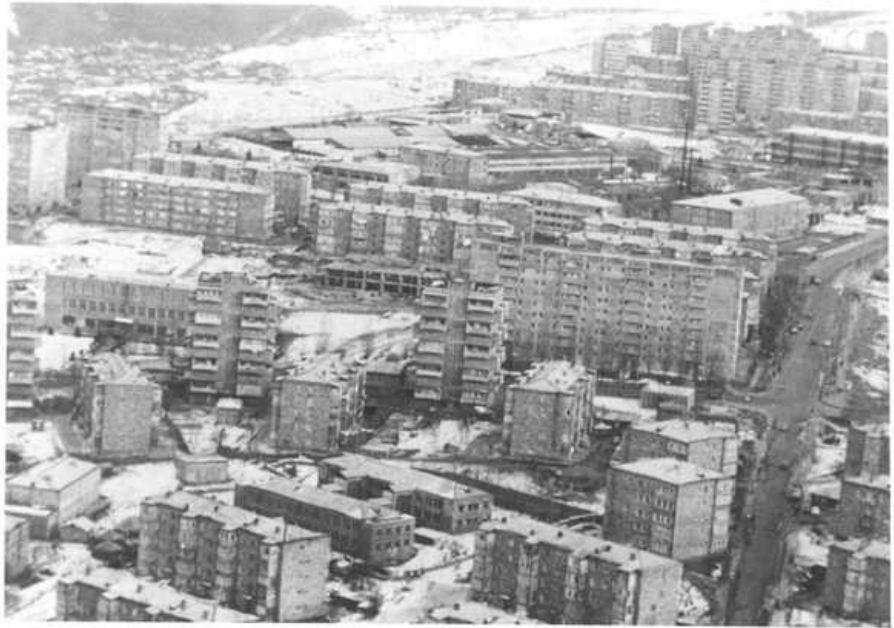
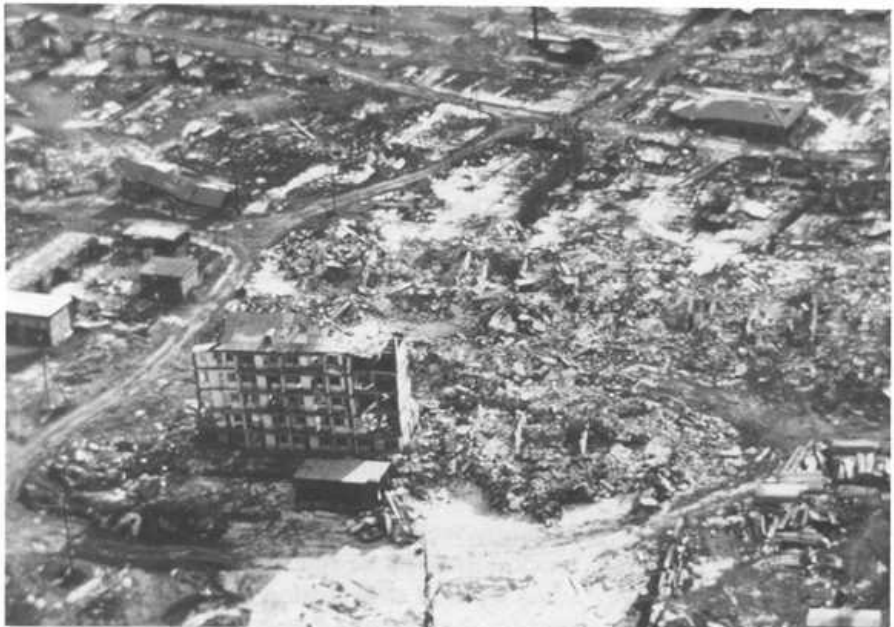
Contrasting earthquake effects on similar types of multi-story building clusters in Kirovakan at top and Spitak at bottom. (Photos courtesy of L. Cluff.)

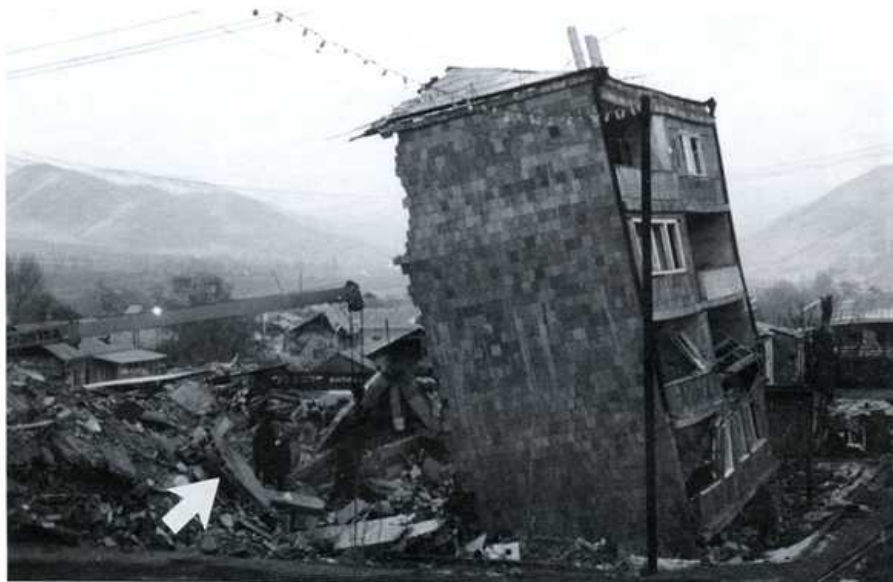
Remains of an unreinforced masonry structure with precast elements in Spitak. Arrow indicates hollow-core floor plank in rubble.

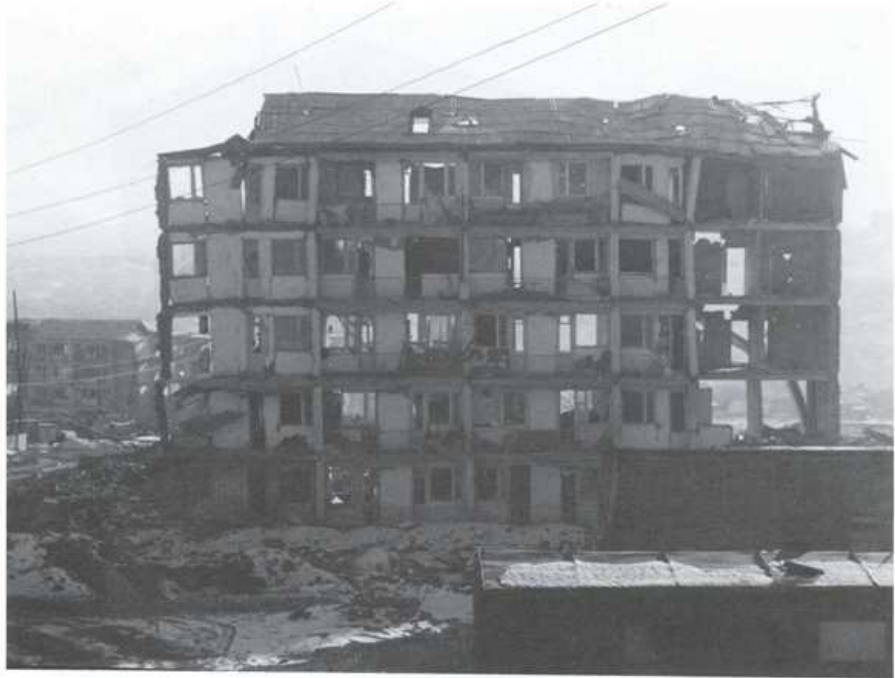
Remains of a five-story precast-concrete-frame residential building in Spitak.

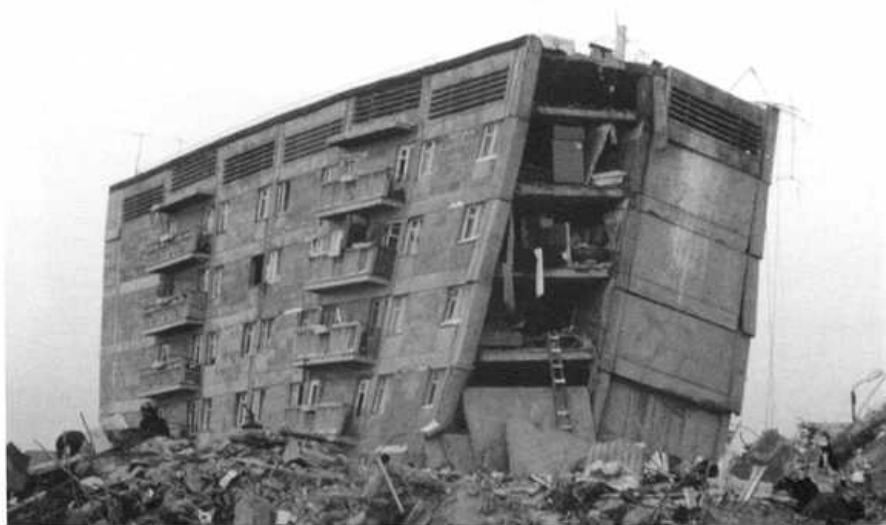
Rubble of several collapsed precast-concrete-frame buildings in Leninakan in the foreground. A structure of the same design in the background.

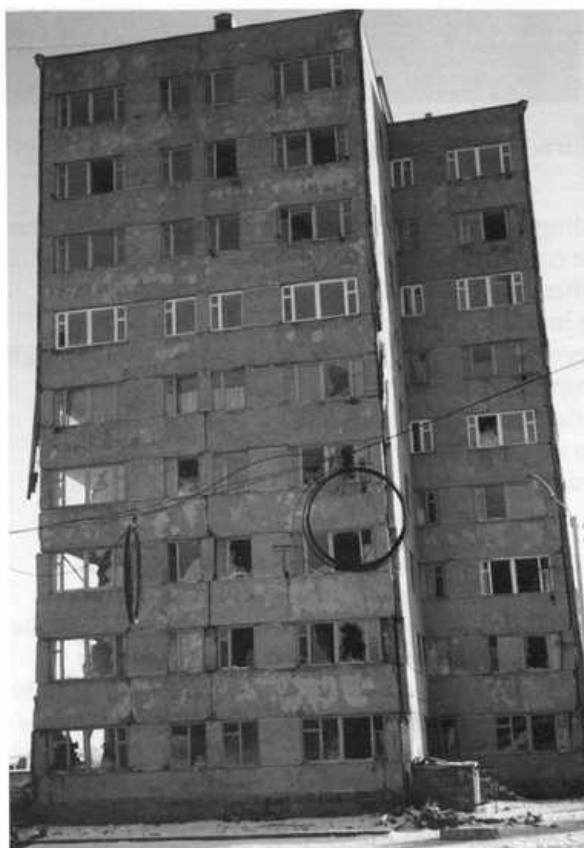
The lower half of this nine-story precast-concrete-frame building in Leninakan sustained the most damage. Separation at wall, floor, and corner connections was the common failure pattern for this type of construction.

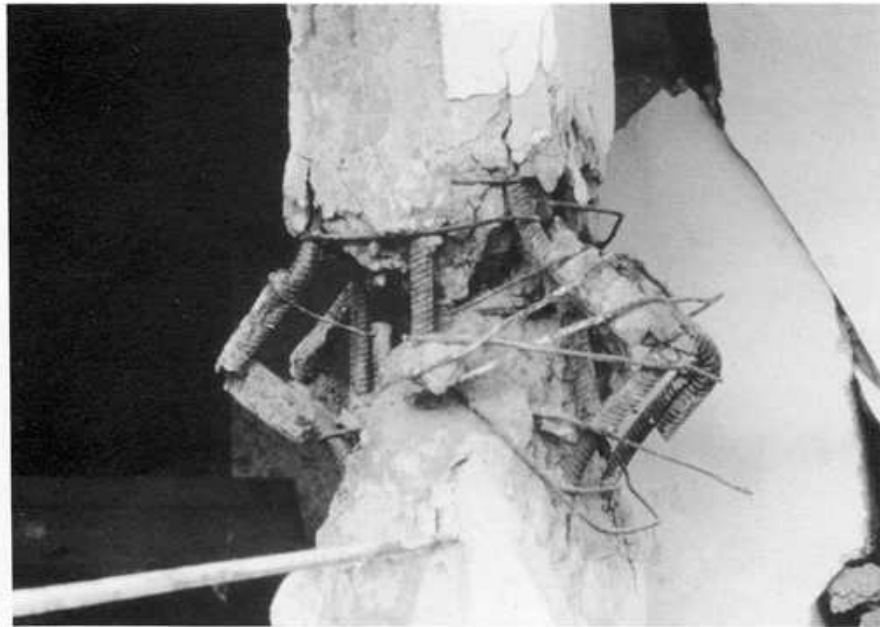
support from precast shear panels, which had large, poorly reinforced openings and weak frame connections. Some of the most severe damage occurred at column splices, which consisted of lap welds of reinforcing bars extending from the upper and lower column sections. Examination of both the damaged structures and those currently under construction indicated that quality control of the field work was poor and that the splices were inherently eccentric with minimal hoop reinforcement for confinement. The strong ground shaking apparently initiated buckling of column reinforcing splices at these joints, resulting in progressive failures of the building frames.

Buckled connection between two precast-concrete columns joined end-to-end at mid-story height.

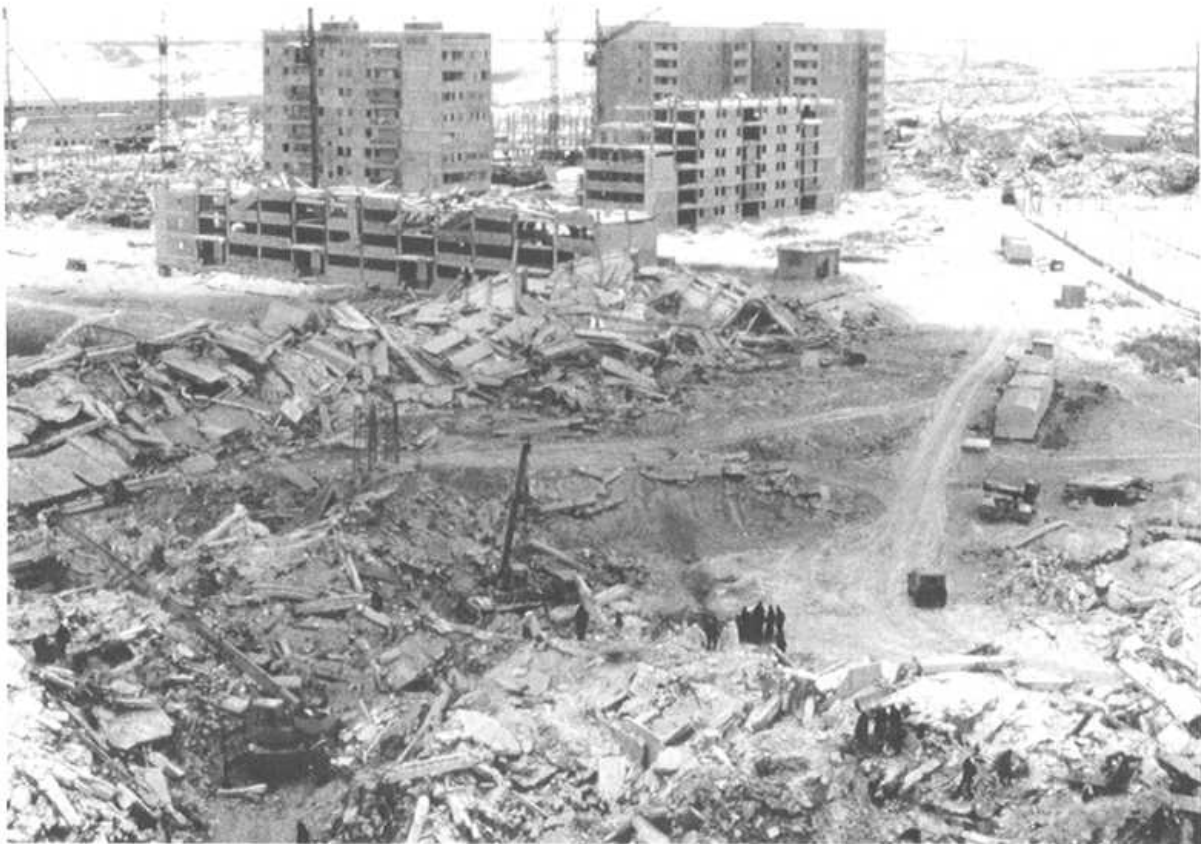
In Leninakan the tall large-panel structures under construction in background sustained little damage. Foreground has wreckage of several nine-story precast-concrete-frame structures. (Photo courtesy of T. O'Rourke.)

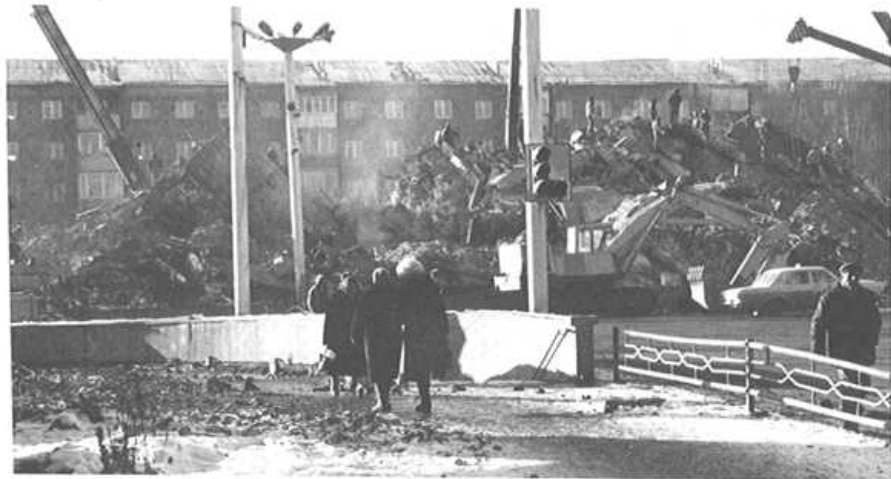
The two cores in the 10-story structure were joined by slabs. It is probable that these cores were not adequately tied together, resulting in independent move-

Collapsed 10-story lift-slab building. In foreground, entrance to a subterranean walkway that was undamaged.

ment of the cores and collapse of the building. In the 16-story structure the shear core and attachments of the various precast elements were extensively damaged. Observers noted that reinforcing steel was protruding from the concrete elements, suggesting poor quality control during construction.

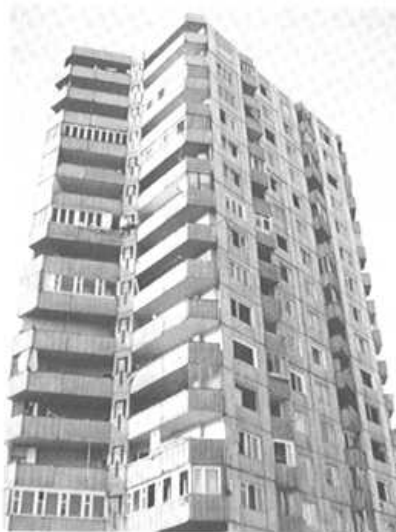
Apparently intact, the 16-story lift-slab structure was in fact damaged beyond repair.

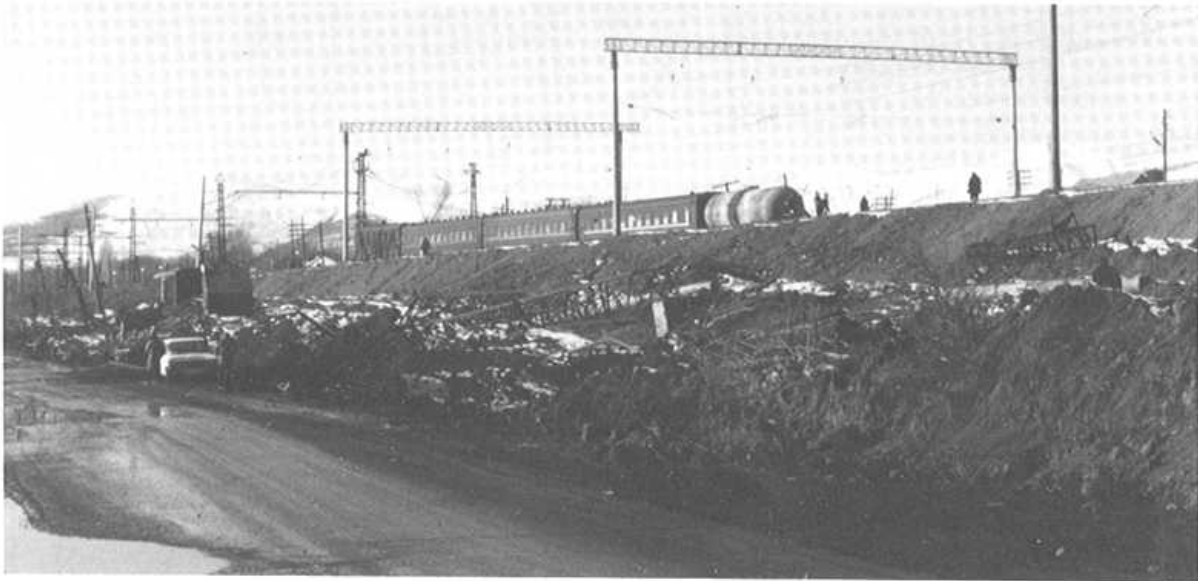
Main rail line at Nalband between Leninakan and Spitak. Ties, rails, and overhead components damaged by massive landslide had been replaced and service restored at time photograph was taken. Part of the landslide debris has been moved to roadside.

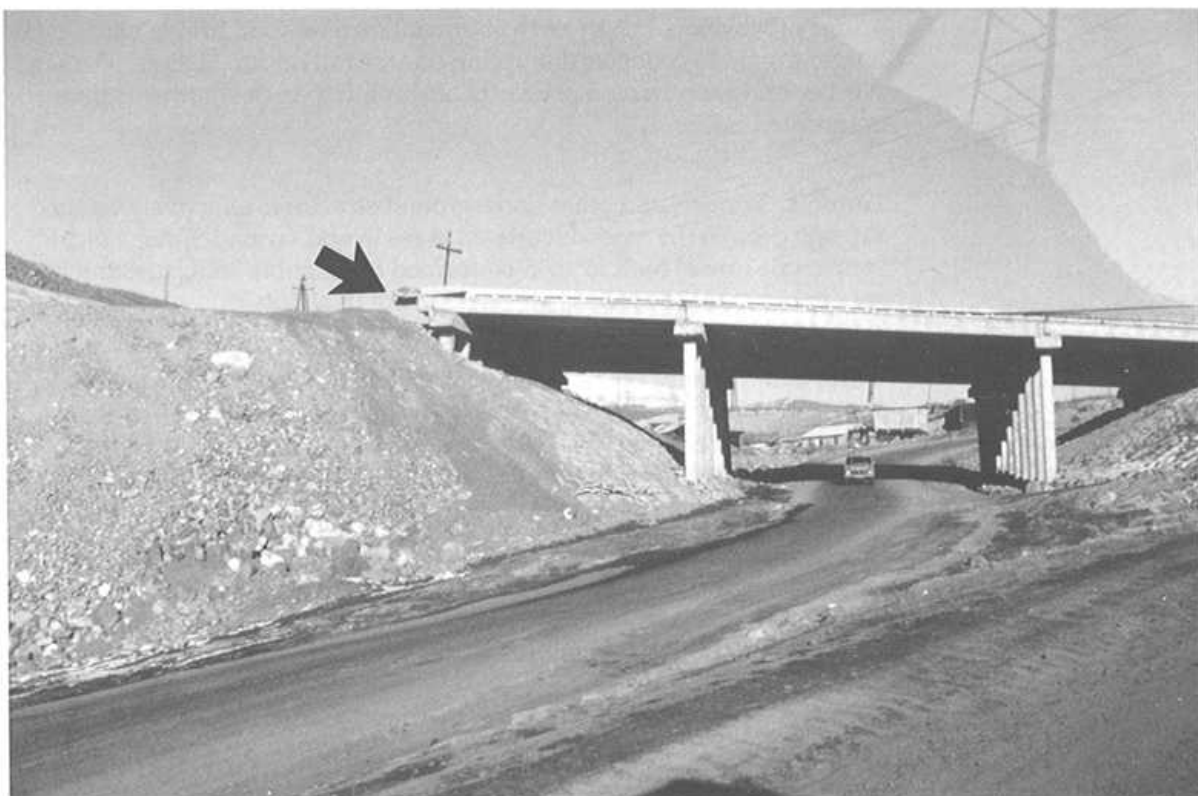
Slumping earth abutments (arrow) damaged both ends of this concrete overpass in west Spitak.

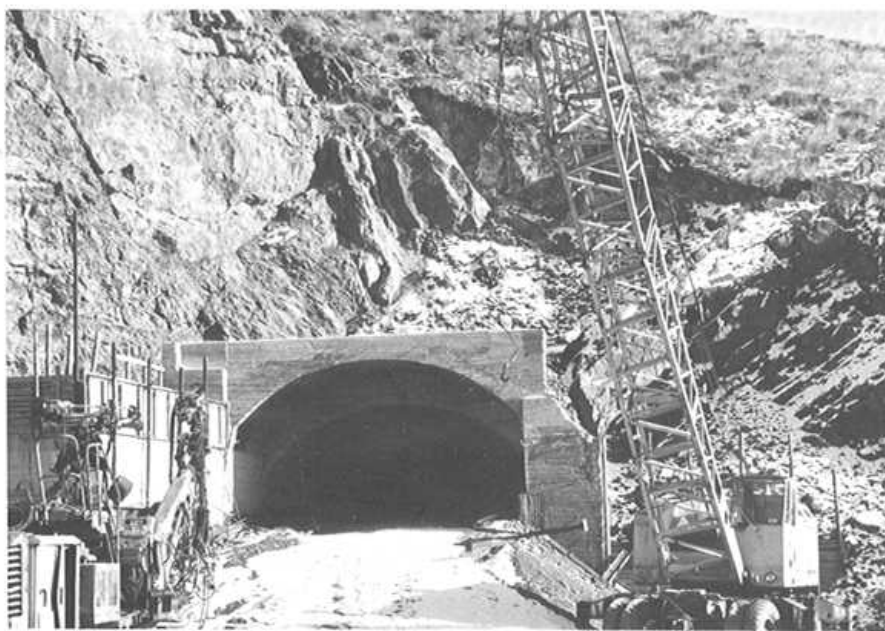
This concrete-lined tunnel under construction near Spitak sustained superficial damage.

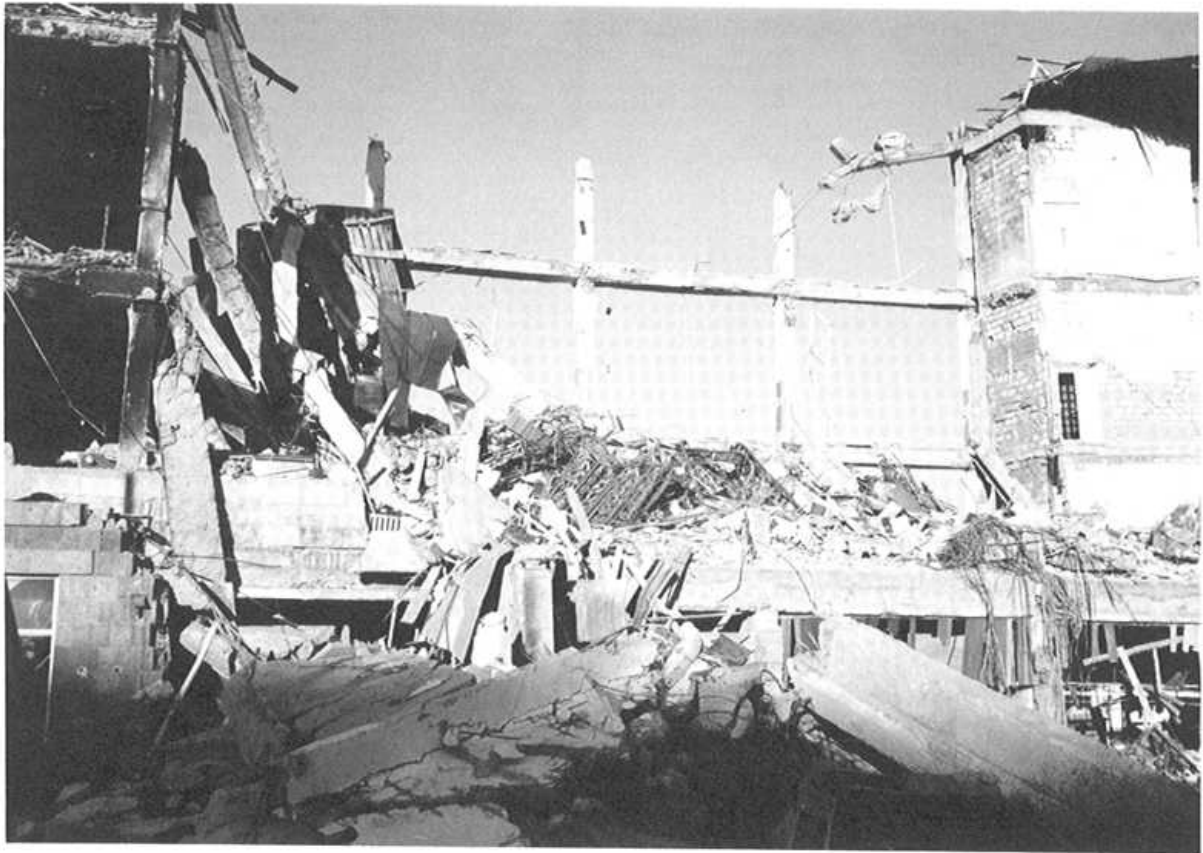
The telephone exchange building in Spitak, a precast-concrete-frame structure with shear end-walls. The failure of poorly connected precast floor planks to act as diaphragms contributed to the collapse. Communication equipment lies amid the rubble on the second floor.

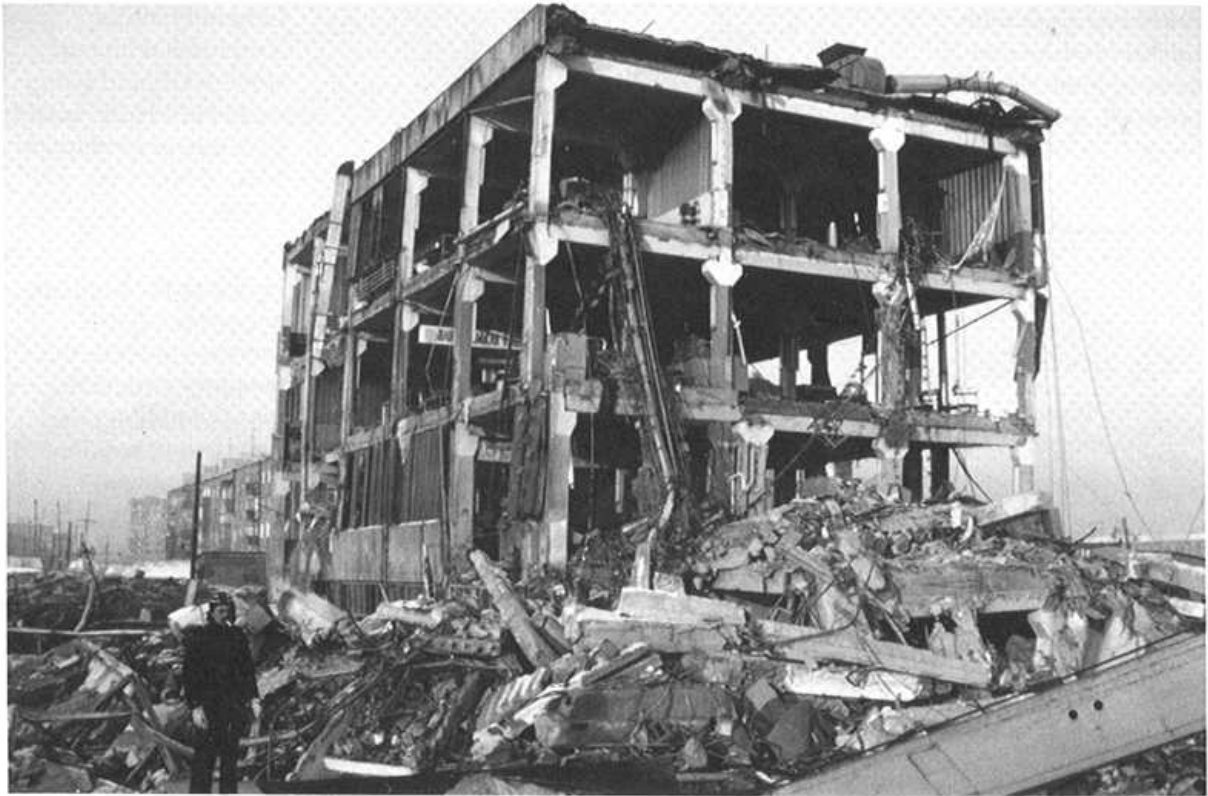
Standing remnant of precast-concrete furniture factory in Leninakan. It was reported that over 300 workers were killed in the collapsed sections of this structure.

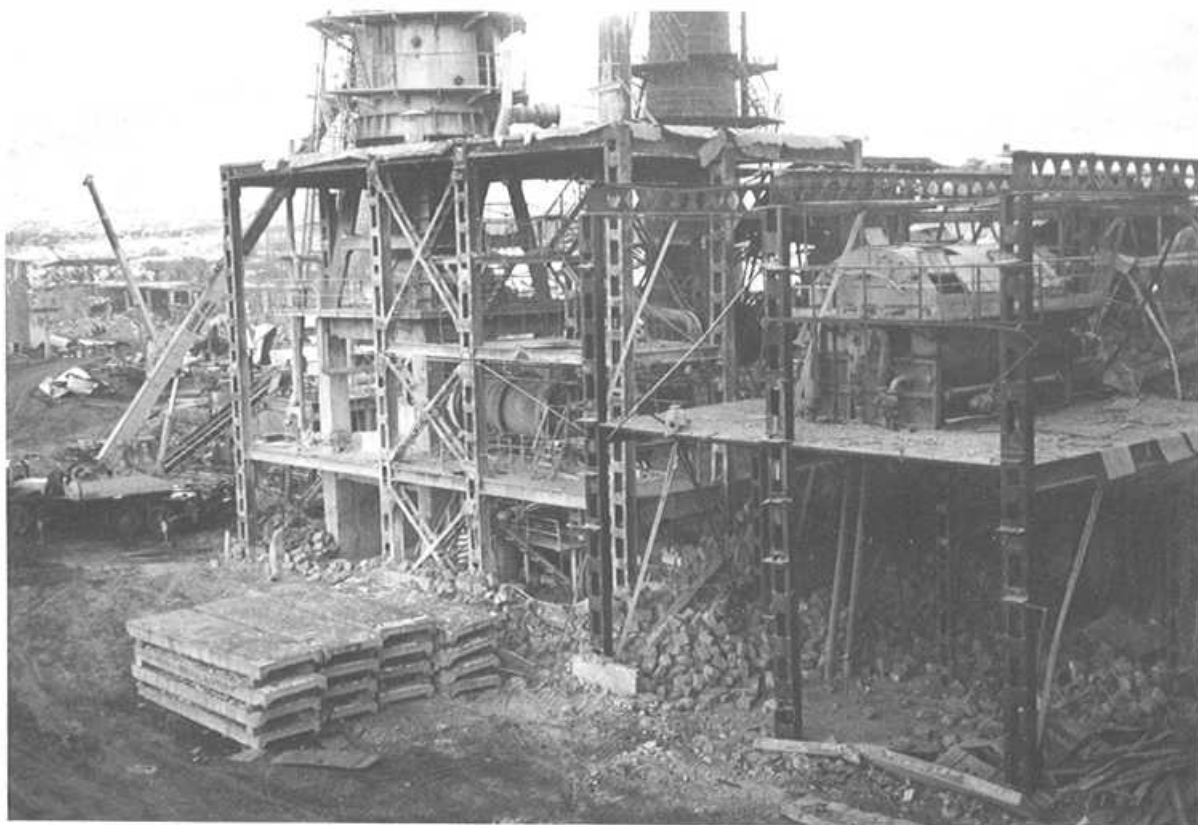
Spilak Sugar Refinery: Precast-concrete and masonry fascia were shaken out of steel frame of main structure. Frame, tanks, and piping are apparently undamaged.

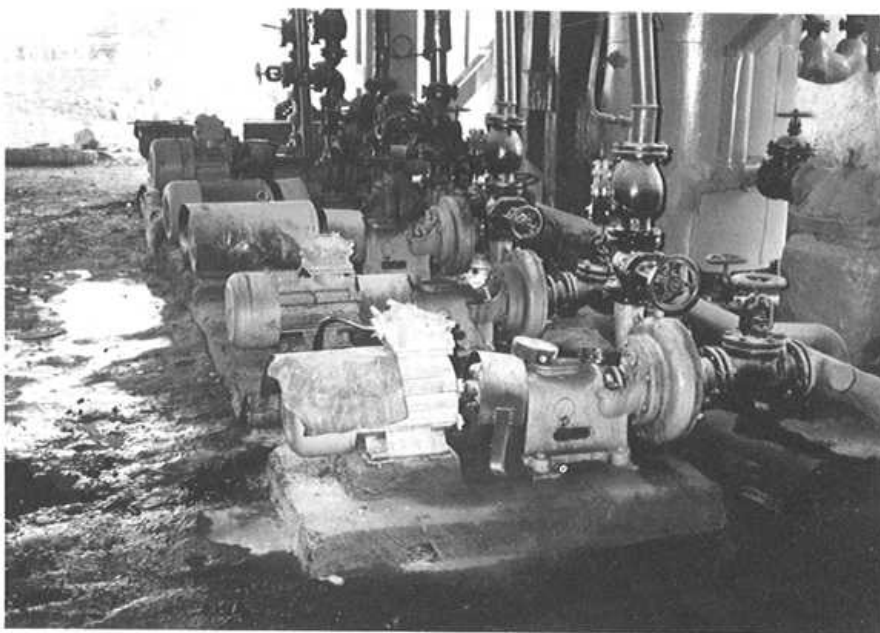
Spitak Sugar Refinery: Piping and horizontal pumps appeared undamaged near masonry and concrete rubble.

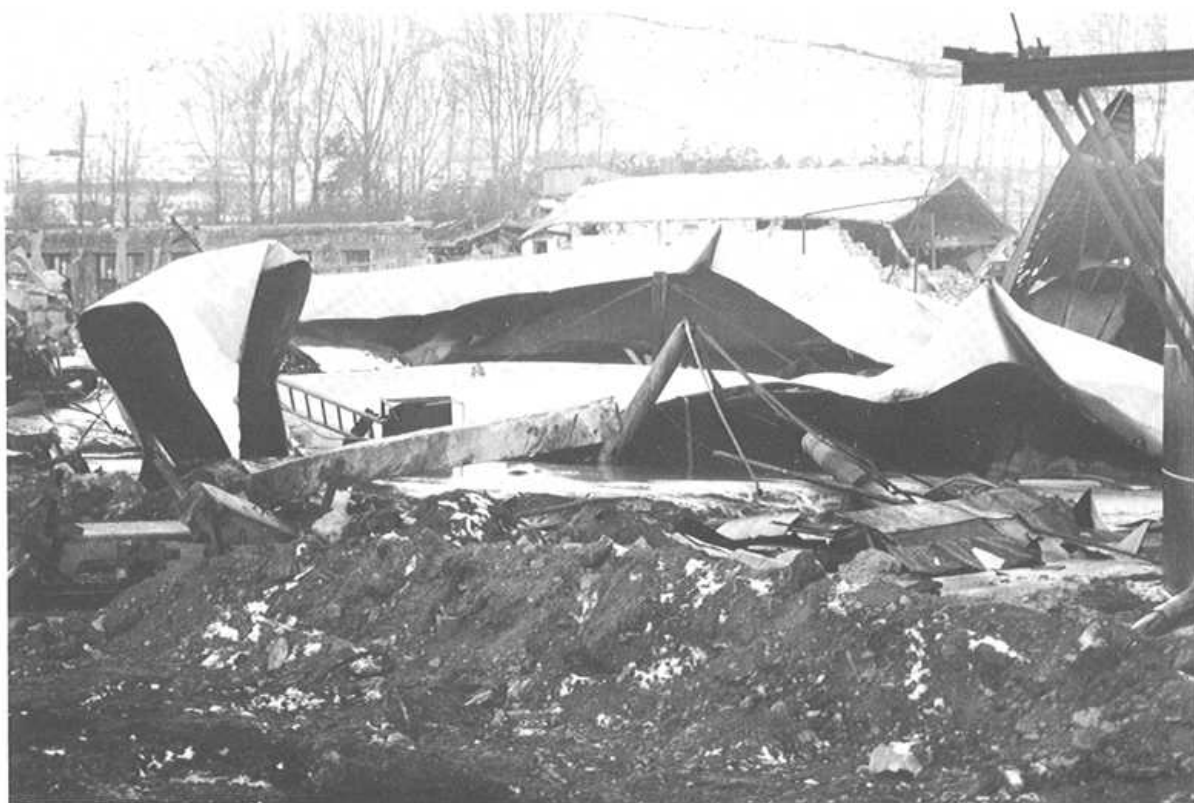
*Spitak Sugar Refinery:
Unanchored and corroded
vertical tanks that had
probably contained liquids
collapsed or sustained severe
damage and lost their
contents.*

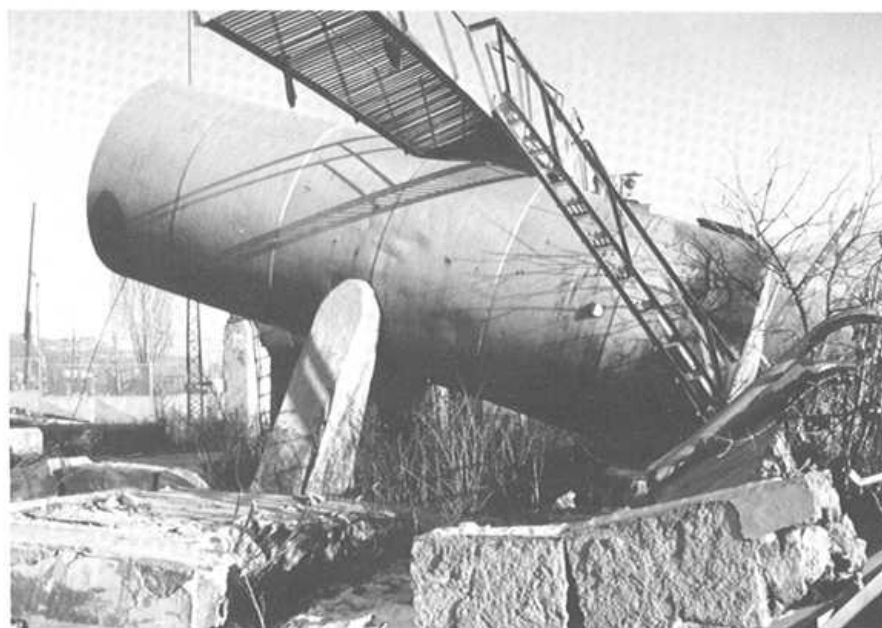
*At a tank farm in Spitak
several horizontal tanks on
elevated supports with narrow
concrete footings toppled. The
tank shells appeared to sustain
minor damage from collapse,
but no damage from inertial
forces. However, piping
ruptured and contents were
lost.*

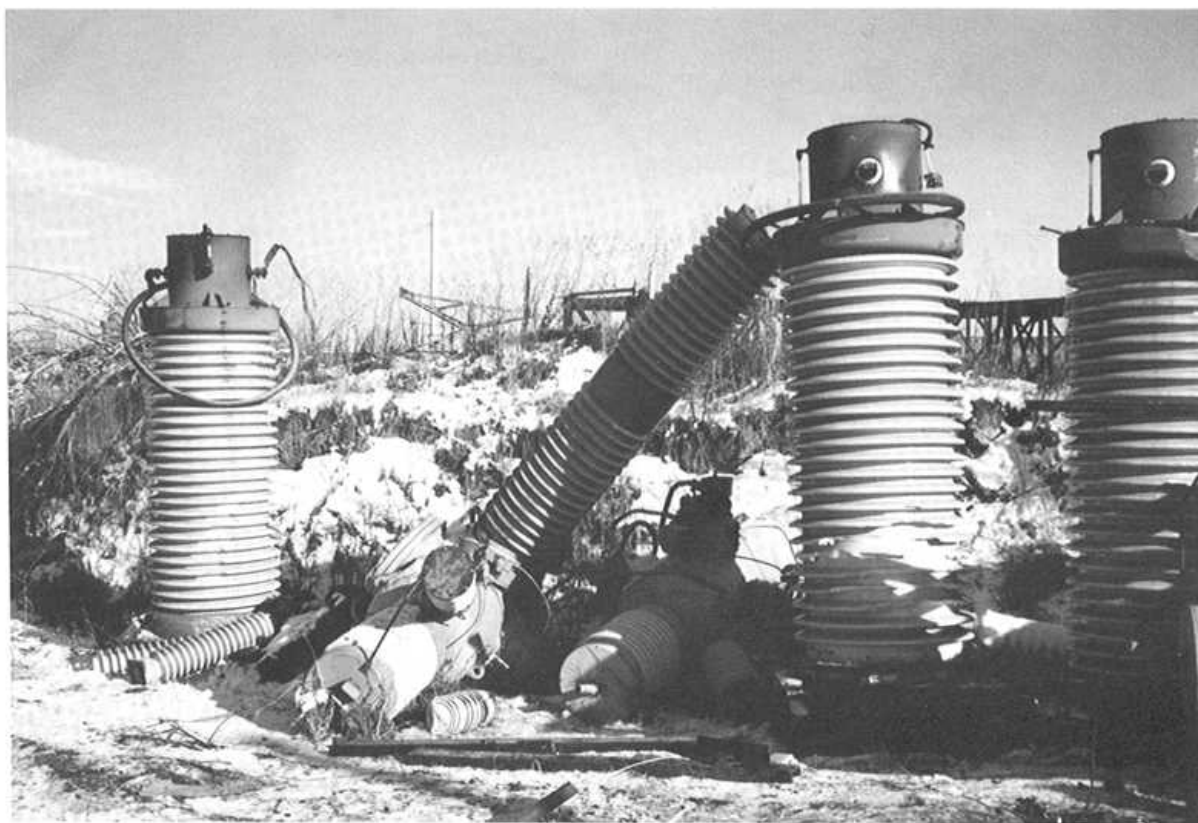
*Leninakan-2 Electric Substation:
Damaged ceramics in the
220 kV yard.*

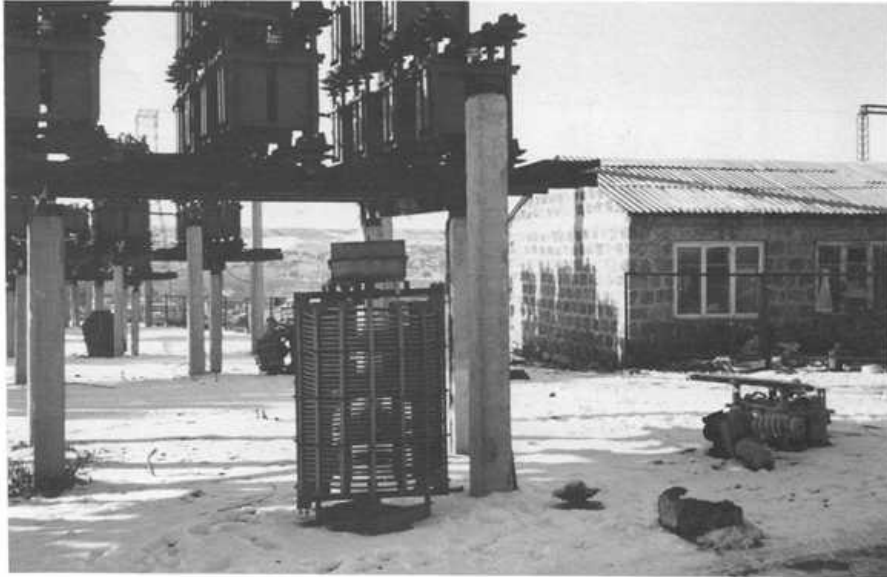
*Leninakan-2 Electric Substation:
Fallen wave traps and ceramics
on ground to right.*

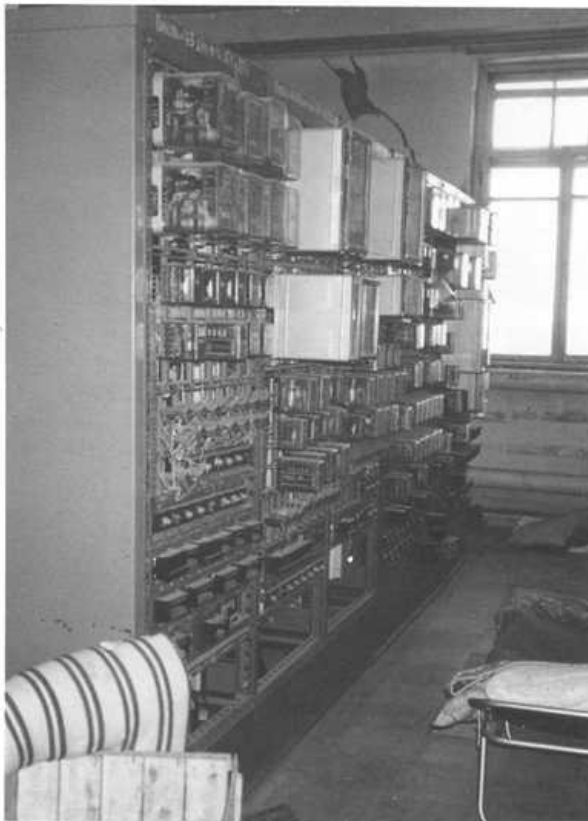
*Leninakan Electric Substation:
Undamaged relay-board cabinets
are welded to steel base-plates.
Note cracked rear wall of heavily
damaged control house.*

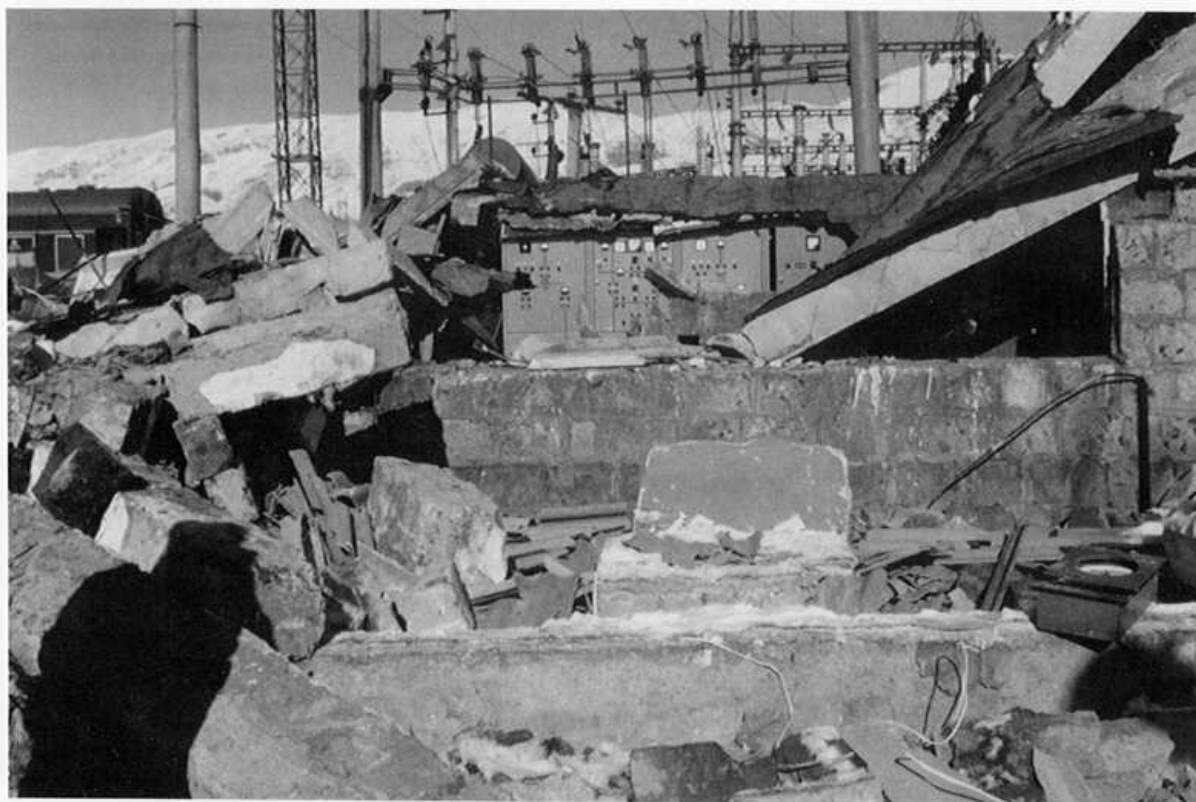
The 110 kV substation at Nalband was almost totally destroyed. The most striking damage occurred to the control house, a one- and two-story concrete-frame building with load-bearing walls. This building collapsed completely and struck nearby bus structures. The control house was a concrete frame structure with unreinforced masonry load-bearing walls. Transformers, circuit breakers, and capacitor banks also sustained damage of varying severity. Shortly after the earthquake, Soviet authorities successfully deployed a rail-mounted substation to restore electrical power in the Nalband area.

*Nalband Electric Substation:
Equipment that apparently
remained intact or had limited
damage within collapsed control
building. Electrical control
cabinets supporting roof
fragment (top), medium-voltage
metal-clad switchgear (bottom).*

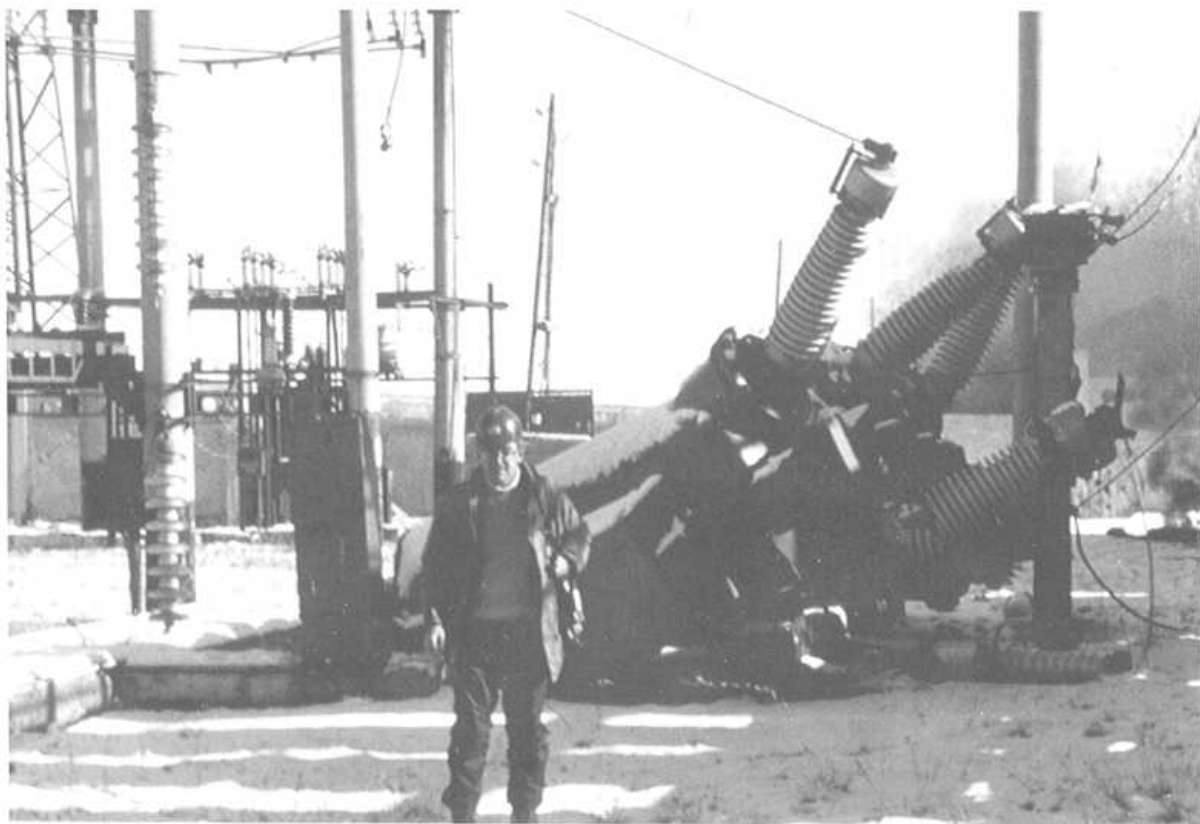
*Nalband Electric Substation:
The elevated concrete footings of
these three oil-filled circuit
breakers failed and the units
toppled to the right.*
