The December 7, 1988 Armenia, USSR Earthquake

An EQE Summary Report

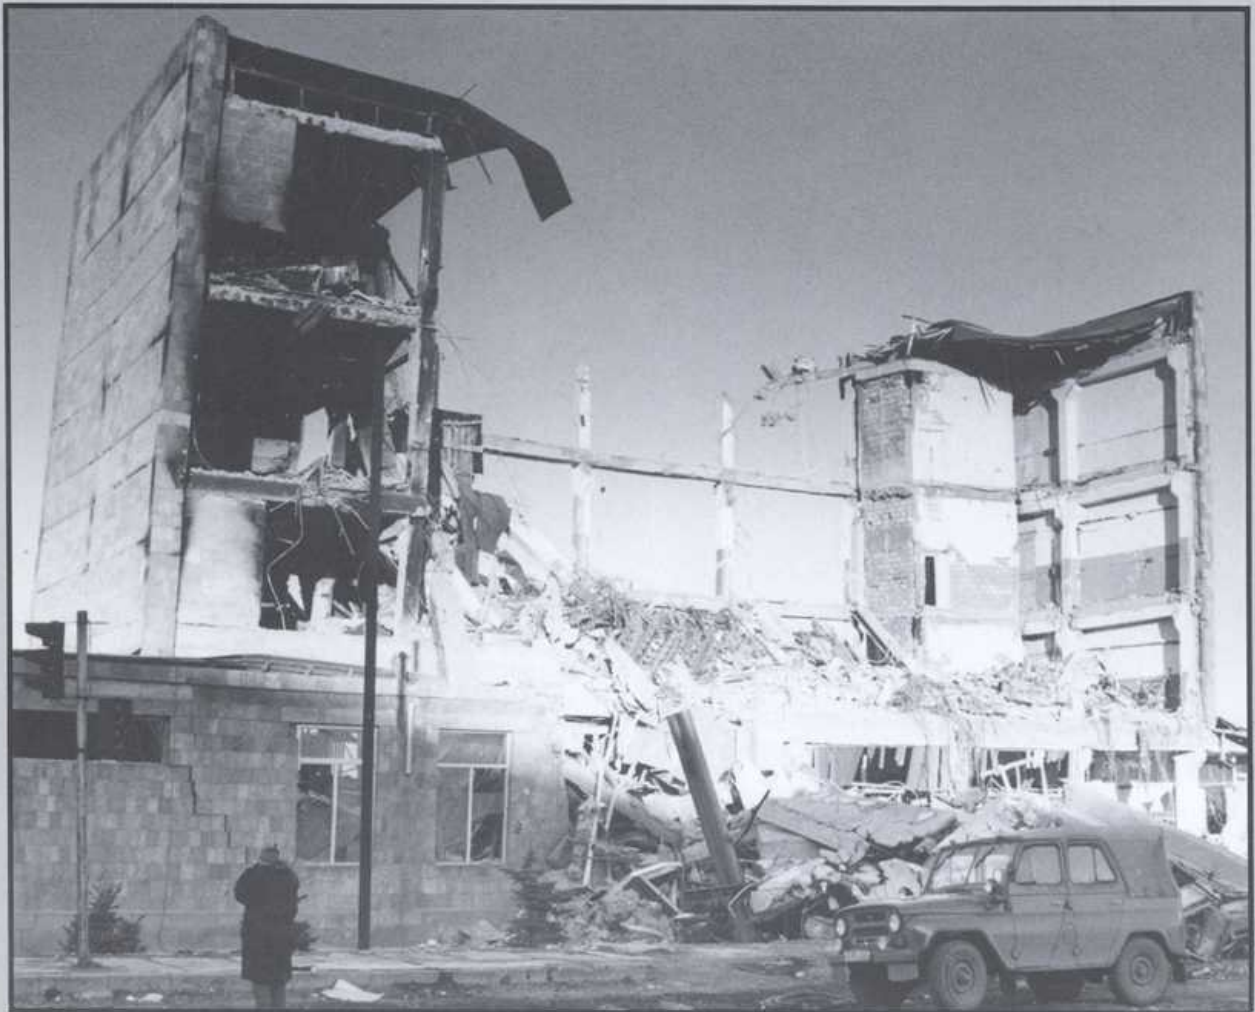
Cover: telephone exchange building in Spitak

The telephone exchange building in Spitak, a precast-concrete-frame structure with shear end-walls. The failure of poorly connected precast floor planks to act as diaphragms contributed to the collapse. Communication equipment lies amid the rubble on the second floor.

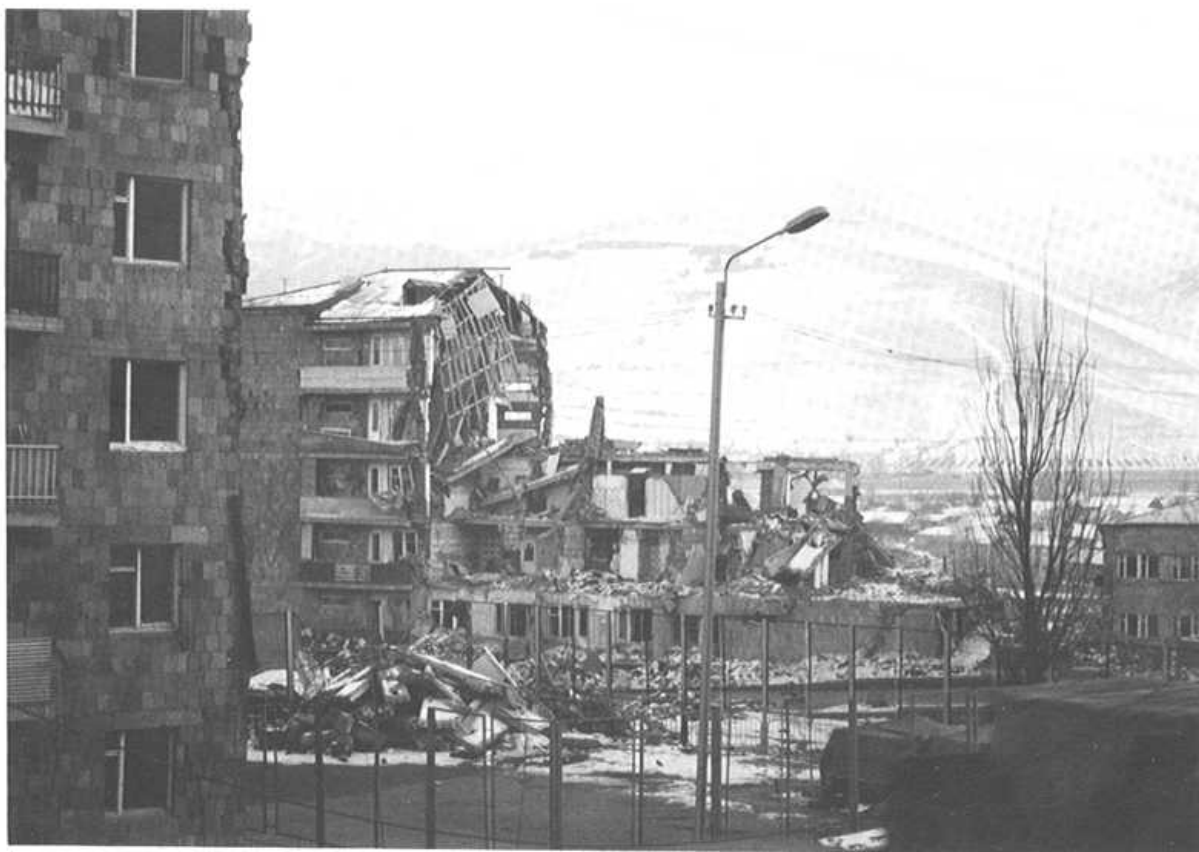
The areas damaged most heavily by the earthquake are in valleys surrounded by ranges of the Caucasus Mountains. View of under-reinforced concrete and masonry buildings in Spitak.

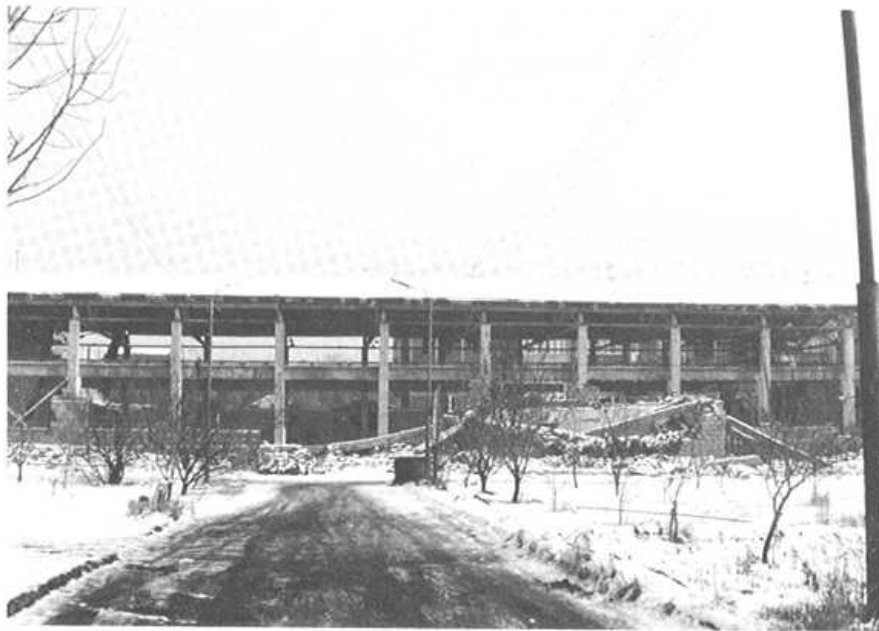
Structural model (top) on a shake table in laboratory of the Earthquake Engineering Research Institute in Leninakan. The model survived. The precast-concrete-frame building that housed it was less successful (bottom).

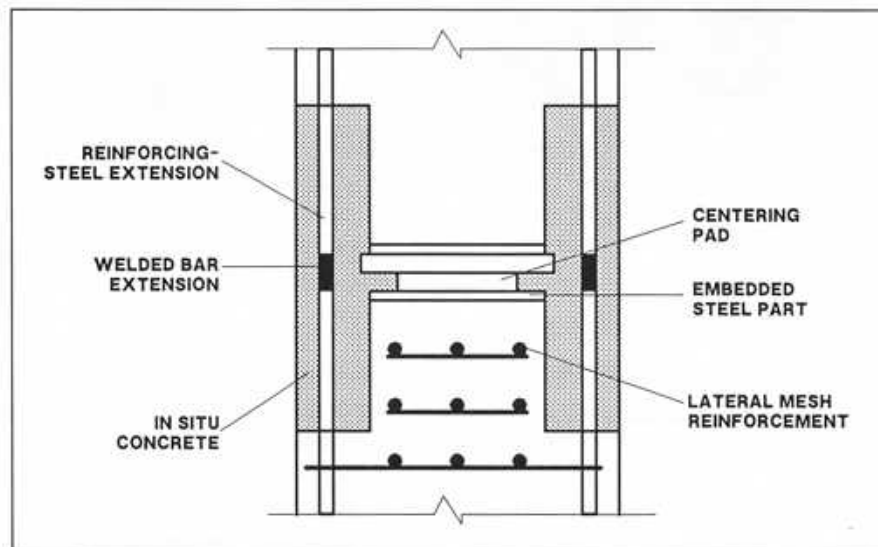
support from precast shear panels, which had large, poorly reinforced openings and weak frame connections. Some of the most severe damage occurred at column splices, which consisted of lap welds of reinforcing bars extending from the upper and lower column sections. Examination of both the damaged structures and those currently under construction indicated that quality control of the field work was poor and that the splices were inherently eccentric with minimal hoop reinforcement for confinement. The strong ground shaking apparently initiated buckling of column reinforcing splices at these joints, resulting in progressive failures of the building frames.

Schematic of end-to-end precast-concrete-column joint.

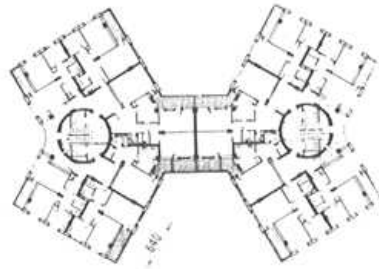
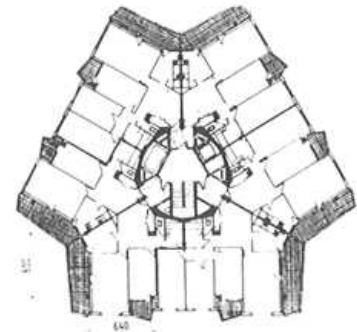
Floor plans of Leninakan's 10- and 16-story lift-slab buildings with double and single shear-cores respectively.

ment of the cores and collapse of the building. In the 16-story structure the shear core and attachments of the various precast elements were extensively damaged. Observers noted that reinforcing steel was protruding from the concrete elements, suggesting poor quality control during construction.

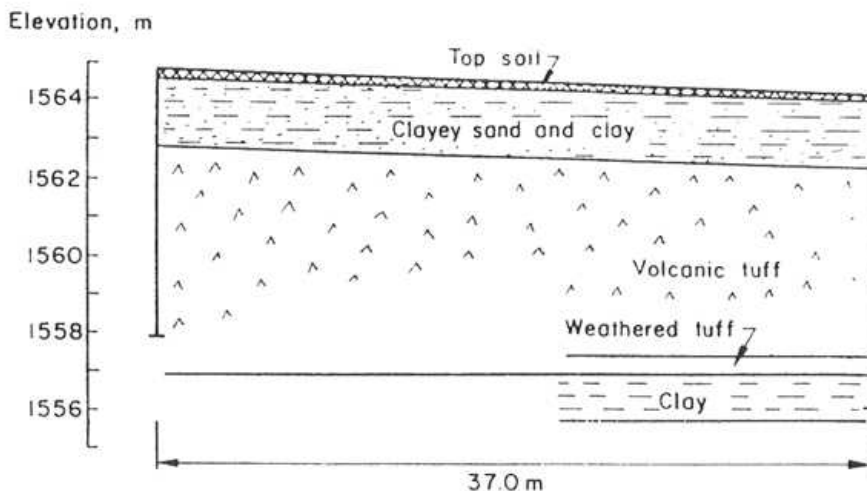
Profile of soil boring taken from site of lift-slab buildings in Leninakan. (Drawing courtesy of T. O'Rourke)

The heavily damaged concrete-lift-slab buildings described above were sited on a hard layer of tuff that was microzoned to shaking intensity VII.

However, this layer is only about 4 meters thick and is underlain by a column of softer sediments over 200 meters thick. In addition this zone is immediately adjacent to an area with a riverbed that had been microzoned for shaking intensity IX. These distinctions are excessively fine for so small an area. General recommendations on microzonation are included in Chapter 7.

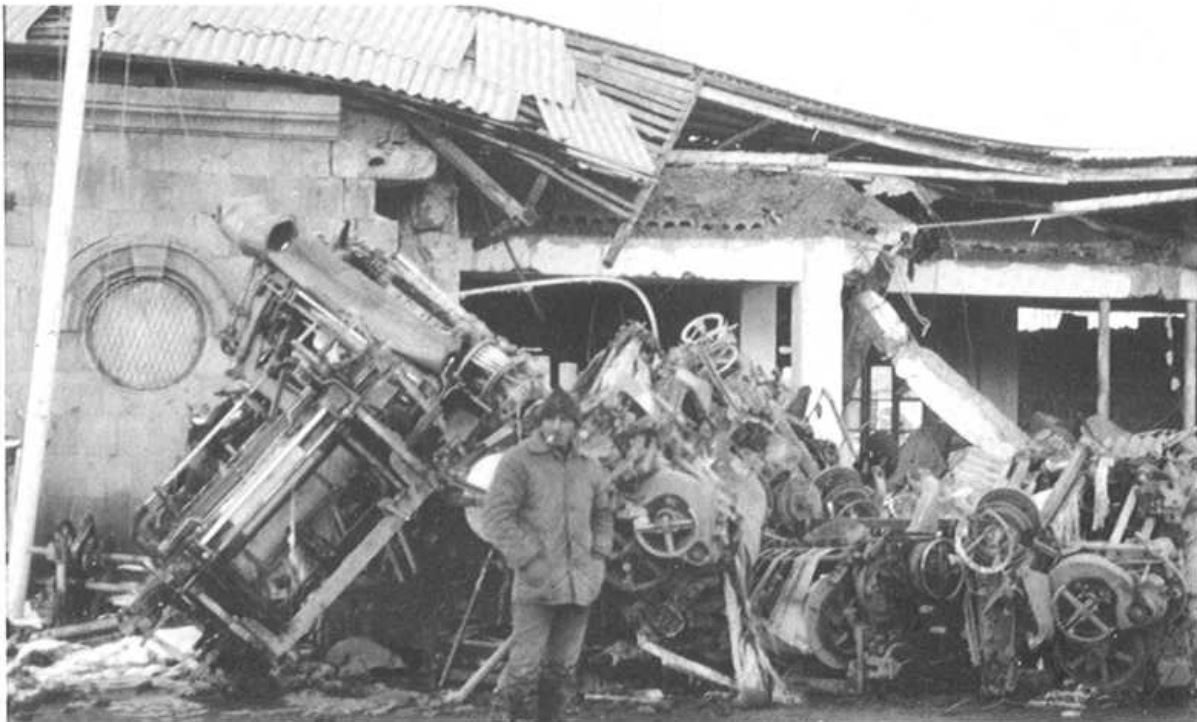
Textile factory in Leninakan prior to earthquake and smashed textile equipment at another site following event.

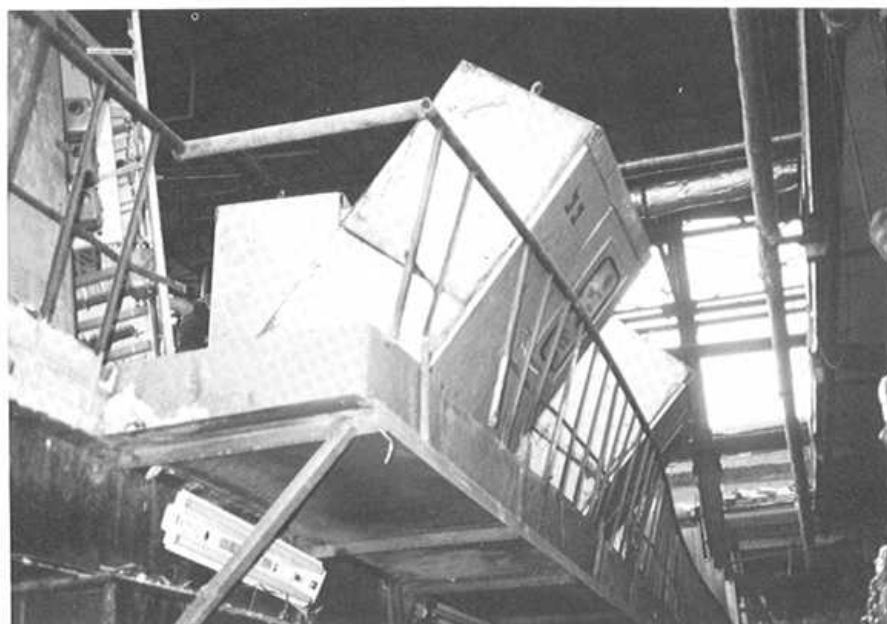
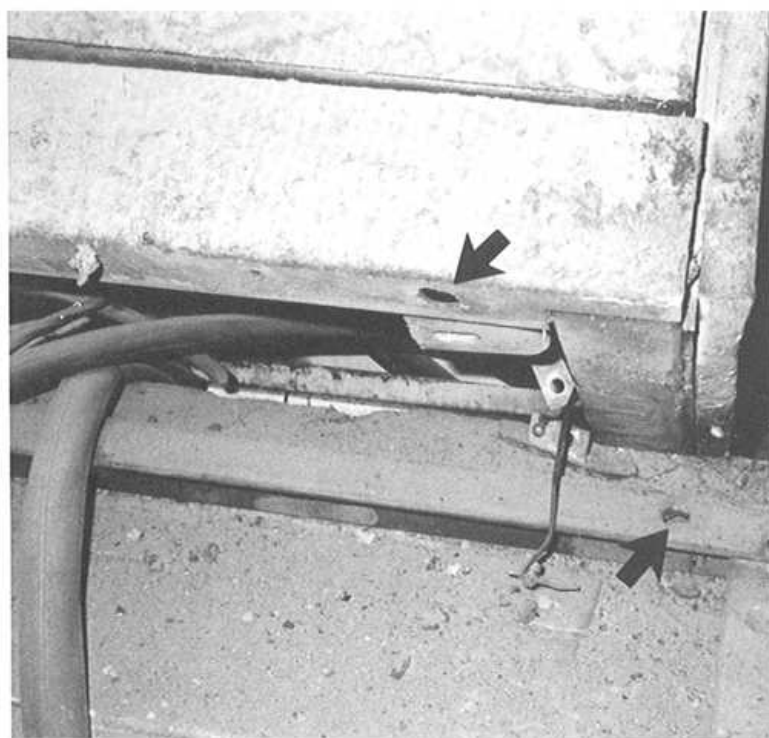
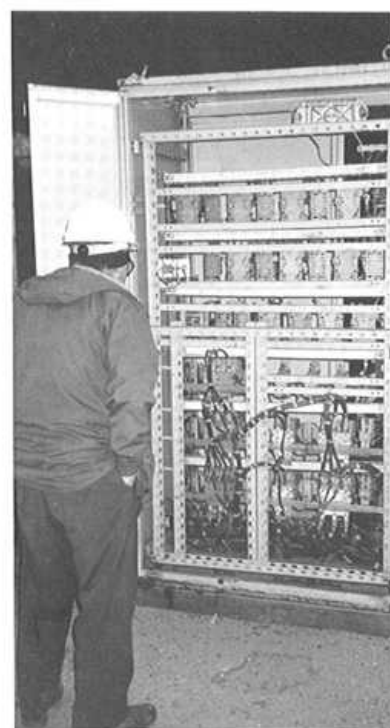
Spitak Sugar Refinery: Toppled electrical cabinets and detail of base where two poorly executed puddle welds (arrows) failed to stabilize unit. Another cabinet (bottom right) remained welded to its steel base-plate and was undamaged.

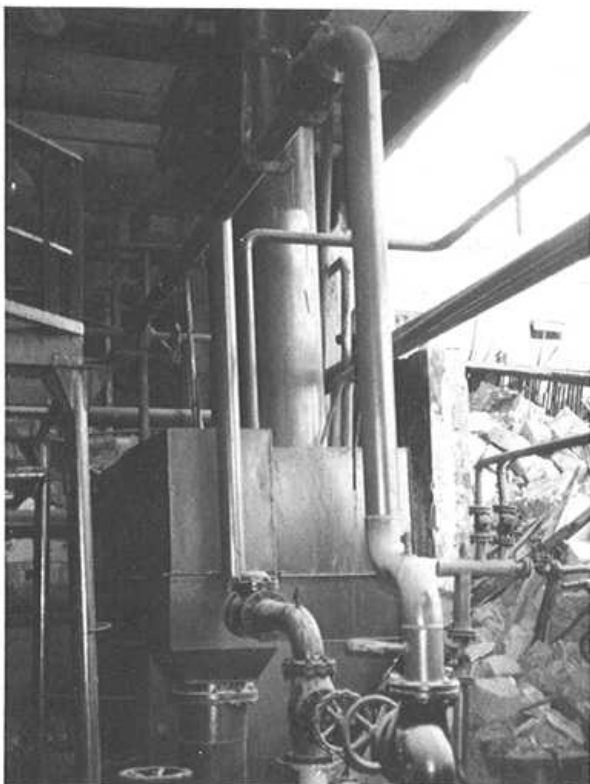
Spitak Sugar Refinery: Piping and horizontal pumps appeared undamaged near masonry and concrete rubble.

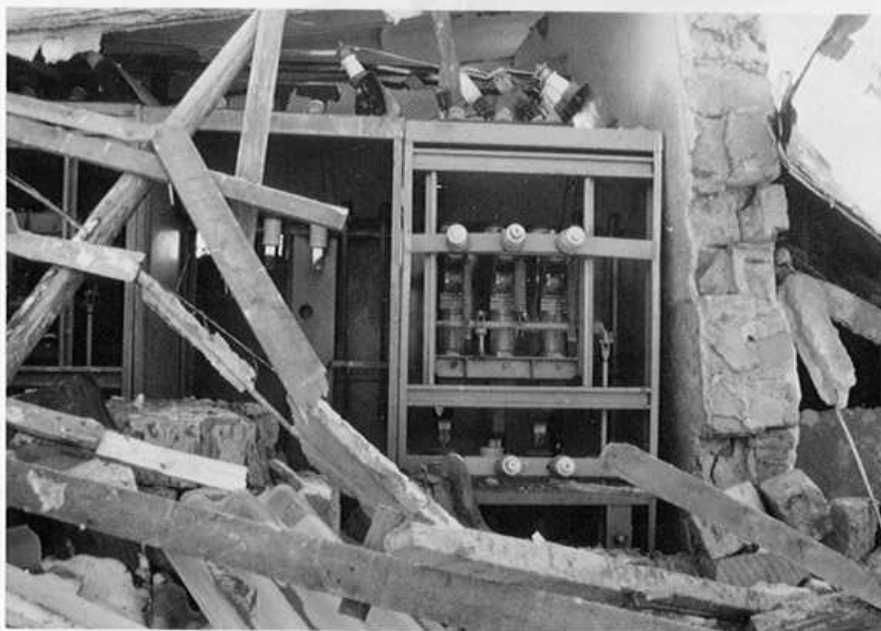
*Nalband Electric Substation:
Equipment that apparently
remained intact or had limited
damage within collapsed control
building. Electrical control
cabinets supporting roof
fragment (top), medium-voltage
metal-clad switchgear (bottom).*

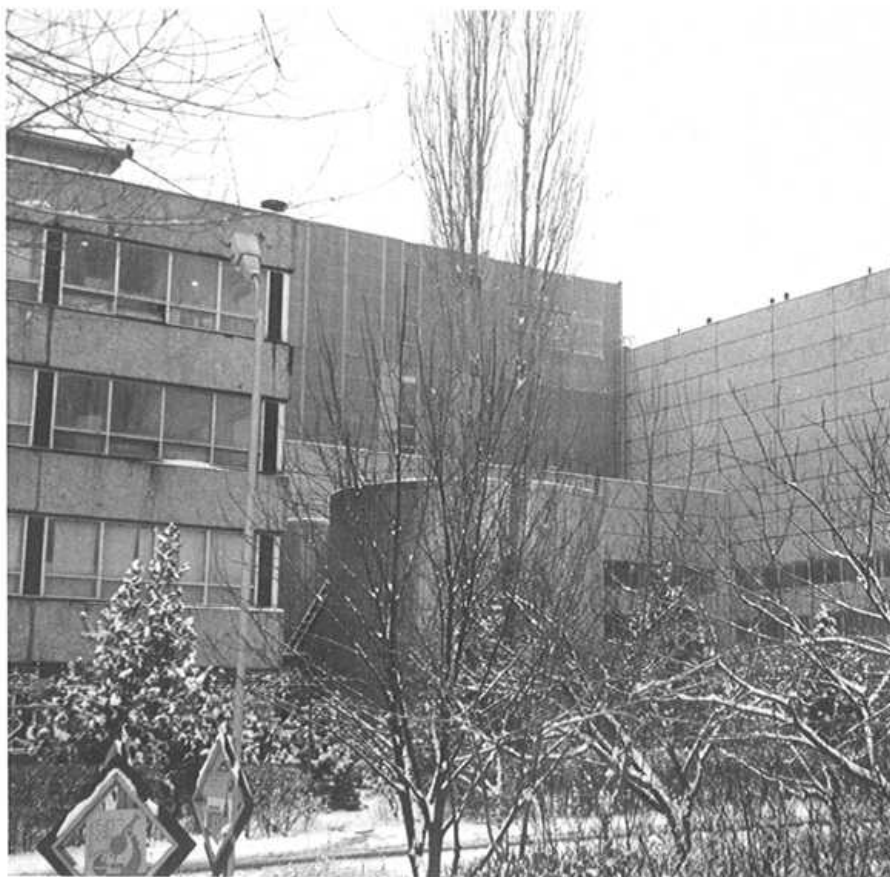
*Armenia Nuclear Plant:
From left to right, office
building (precast-concrete-
frame), Unit 1 reactor
building (concrete-shear
wall), Unit 1 turbine building
(steel-frame with precast-
concrete fascia).*

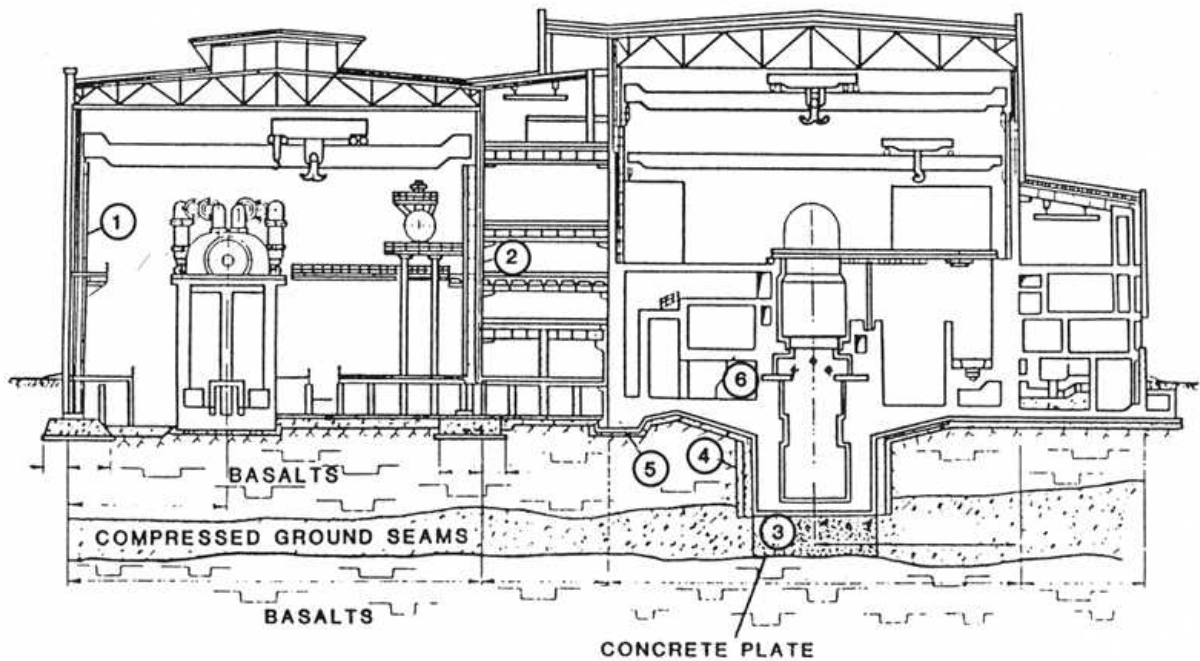
Armenia Nuclear Plant: Cross section of Main Building, Unit 2. Numbers identify seismic upgrades made following the 1976 Vrancea earthquake. 1 = steel ties; 2 = reinforced-concrete wall; 3 = concrete plate; 4 = sand fill; 5 = longitudinal concrete rib; 6 = reinforced-concrete rib. (Drawing courtesy of U.S. Department of Energy.)

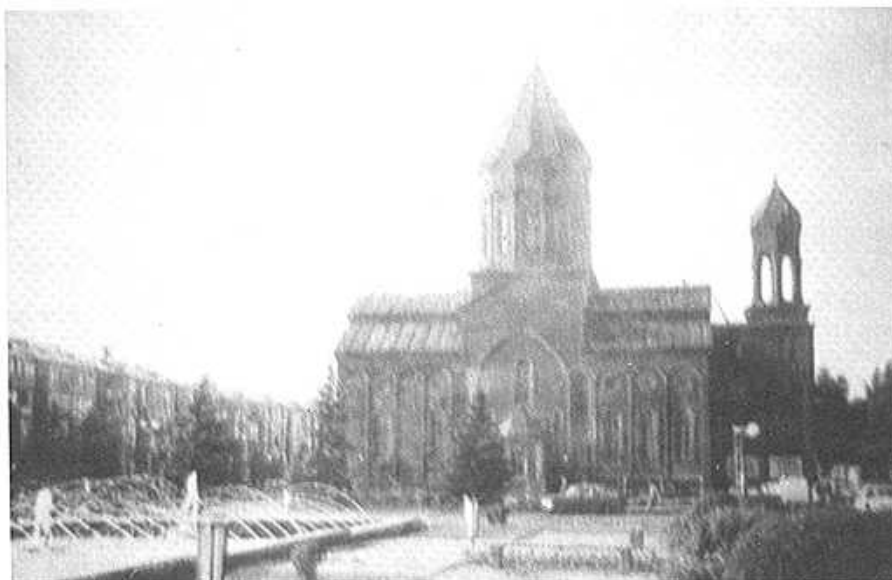
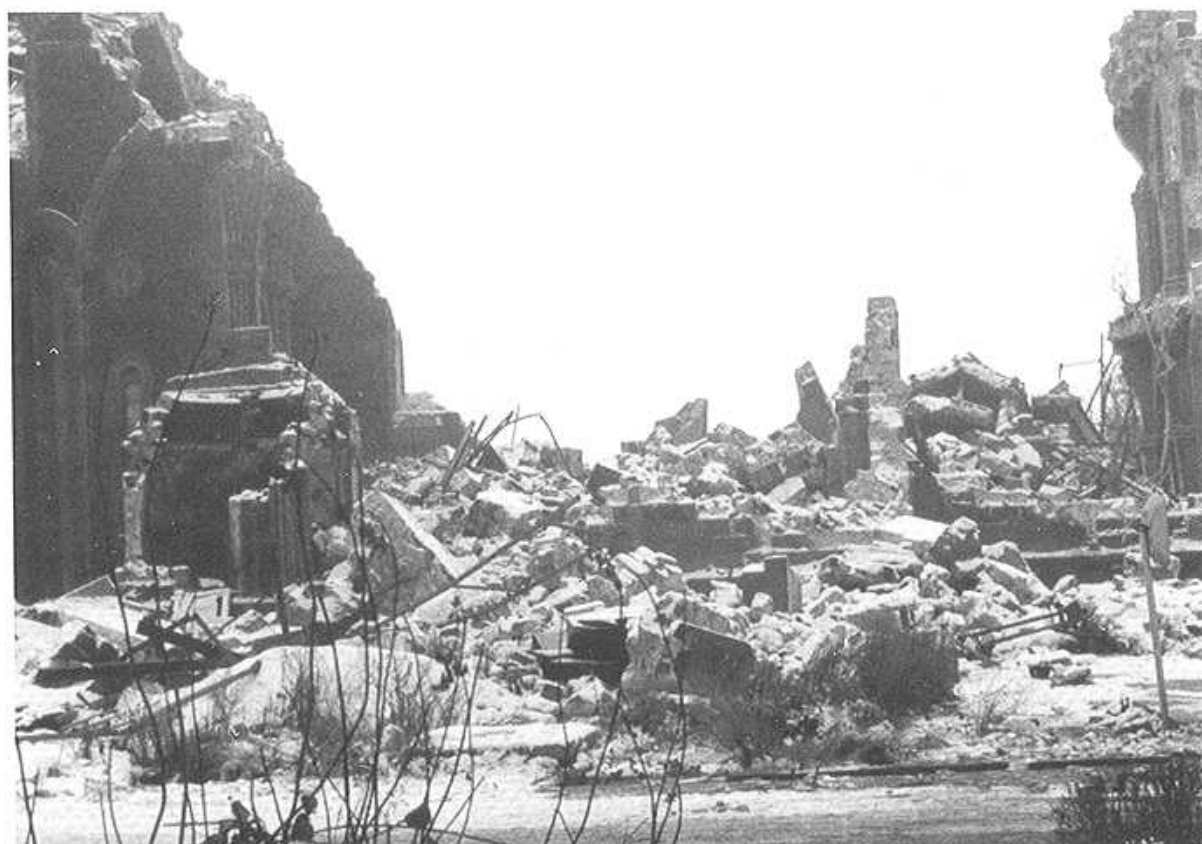
The 19th century cathedral in central Leninakan before and after the earthquake.
